The fire resistance performance of a double leaf single acting doorset with glazing when tested in accordance with BS EN 1634-1: 2014 and BS EN 1363-1: 2012

BMT/FEP/F16079

Acoustic & Fire Door Solutions Ltd

31st March 2016

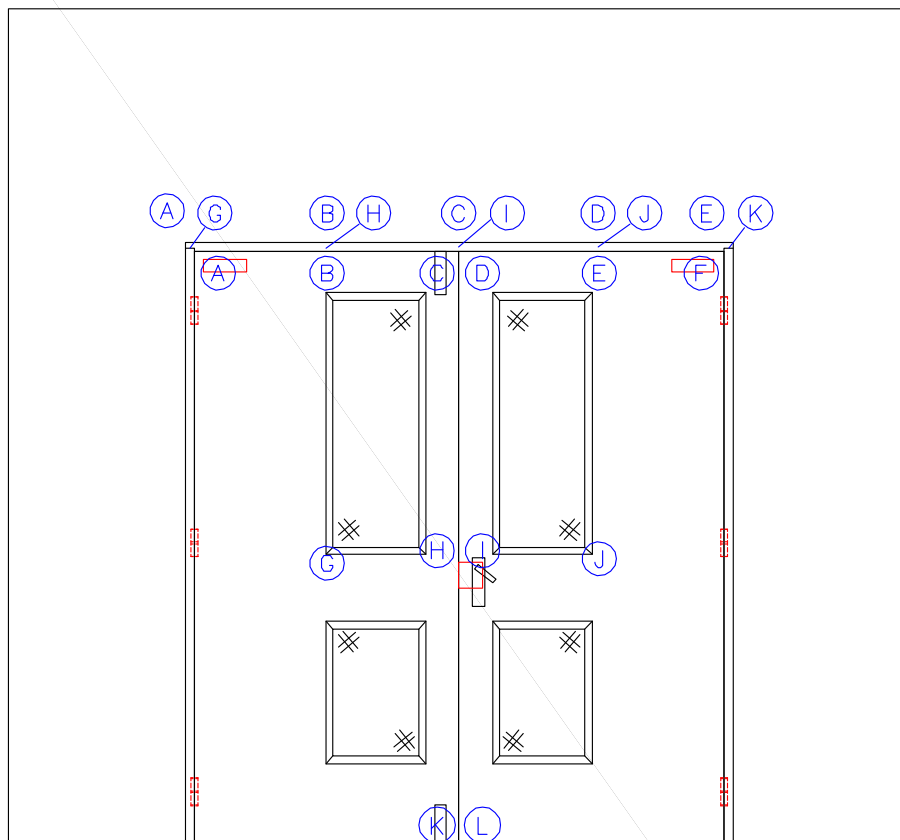
The following tables show the distortion in mm with an accuracy of ± 1 mm.
A positive measurement indicates distortion towards the furnace.
A negative measurement indicates distortion away from the furnace.

Time	A	B	C	D	E	G	H	I	J	K
10	1	-1	-3	1	-1	1	3	1	1	-3
20	6	9	10	12	6	9	10	9	11	8
30	24	32	35	-	-	31	34	33	-	-

Time	A	B	C	D	E	F	G	H	I	J	K	L
10	3	2	1	1	2	0	9	0	-2	-9	-7	-7
20	11	14	11	14	14	11	27	5	2	28	-8	-7
30	37	37	32	-	-	-	-	-	-	-	-	-

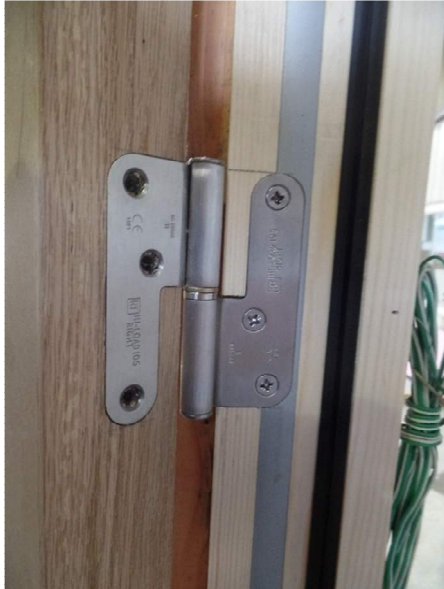
Make/type	Size (mm)	Location
Around hinge blade	Partially interrupted	-	Hinge blade partially interrupts seal in frame reveal with 2mm remaining continuous
Under hinge blades	STS ST100X30R Interdens	1 thick	Fitted under hinge blade on frame and leaf
Encasing latch body	STS ST100X30R Interdens	1 thick	Fitted around the body of the latch
Under latch forend	STS ST100X30R Interdens	1 thick	Fitted under the latch forend
Around latch keep	Fully interrupted	-	Latch keep fully interrupts both seals in leaf edge
Under latch keep	STS ST100X30R Interdens	1 thick	Fitted under the latch keep
Around drop down seal	Partially interrupted	-	Drop down seal fully interrupts 1 st seal in left leaf edge leaving 2 nd seal continuous
Under drop down seal	None fitted	-	-
Around flush bolt keep	Partially interrupted	-	Flush bolt keep partially interrupts 2 nd seal in frame reveal with 1mm remaining continuous, 1 st seal is continuous

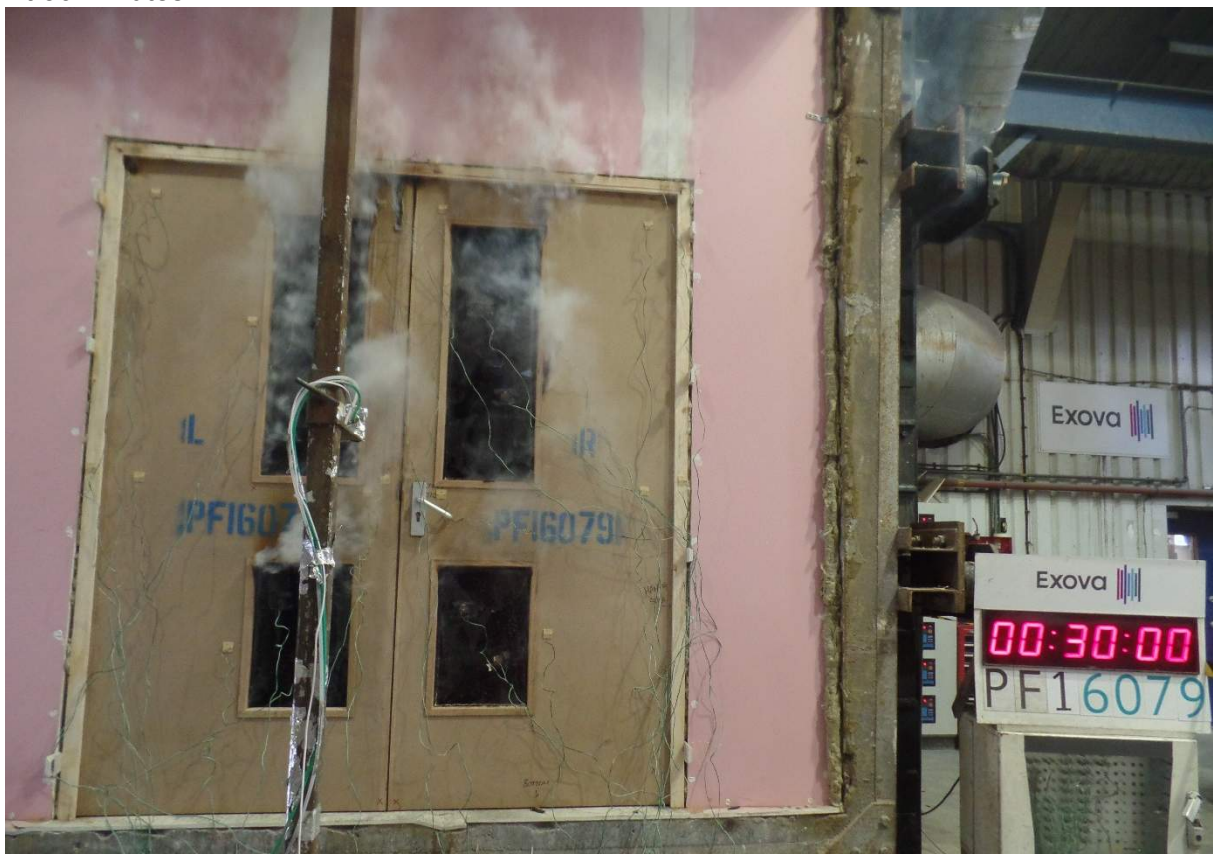
At 30 minutes

31.30	There is continuous flaming from the top left leaf glazing where the glass has fallen away, also 6mm and 25mm gap gauge failures were recorded, thereby constituting to integrity failure

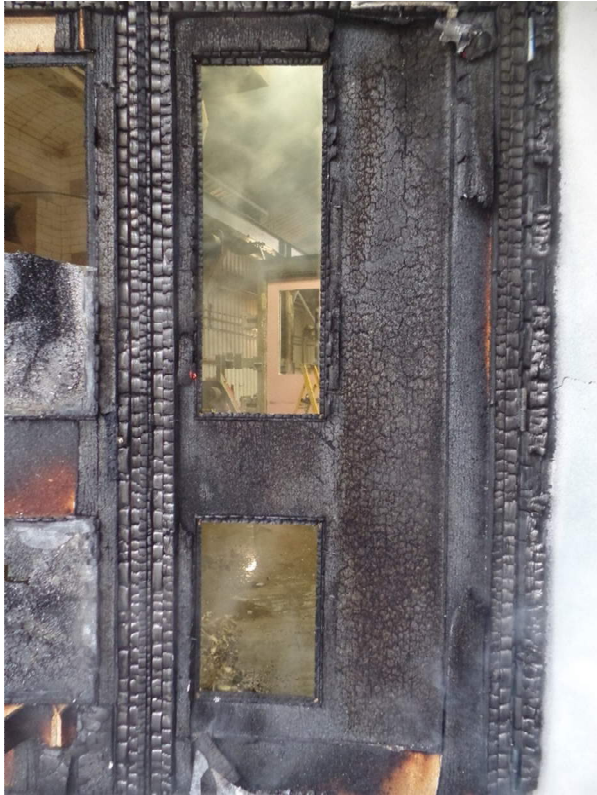
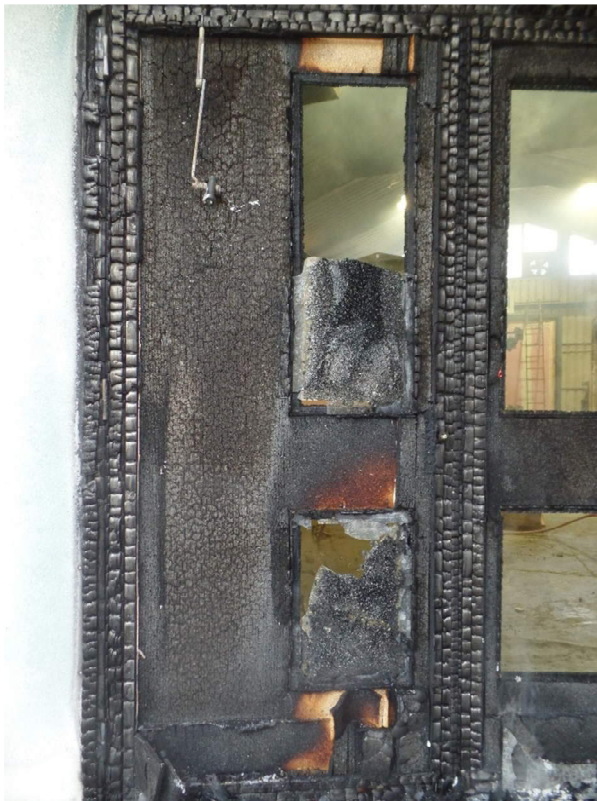
Exposed face post test

06.21	There is smoke issue from the glazing panels at several places
08.25	Left and right glazing reacted and discolouring
10.30	Exposed face both leaves, the MDF facing layer has fallen away
