The fire resistance performance of a double leaf single acting doorset with glazing when tested in accordance with BS EN 1634-1: 2014 and BS EN 1363-1: 2012

BMT/FEP/F16079

Acoustic & Fire Door Solutions Ltd

31st March 2016

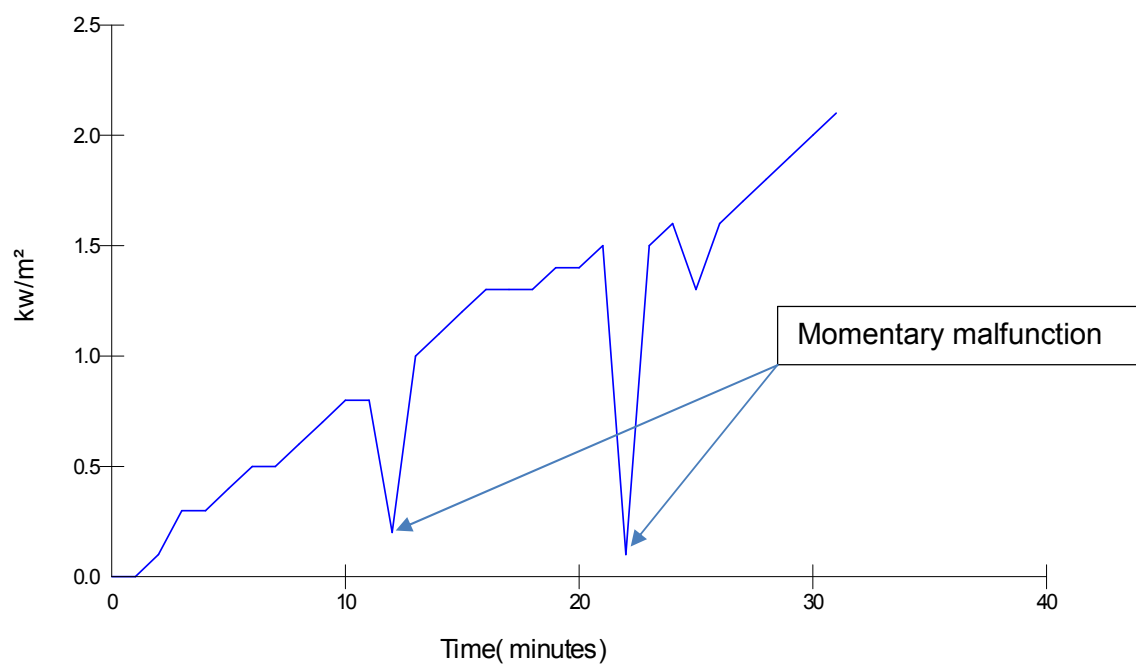
Radiation

A medtherm heat flux radiometer was used to measure the radiant heat 1m away from the centre of the specimen. The readings recorded are tabulated in Appendix 2 and are shown graphically below:
